**SAS Superstructure**

Location: 04-SF-80-13.2 / 13.9

**Daily Diary Report by Bid Item**

Diary #: 147 Const Calendar Day: 385 Date: 28-Sep-2010 Tuesday

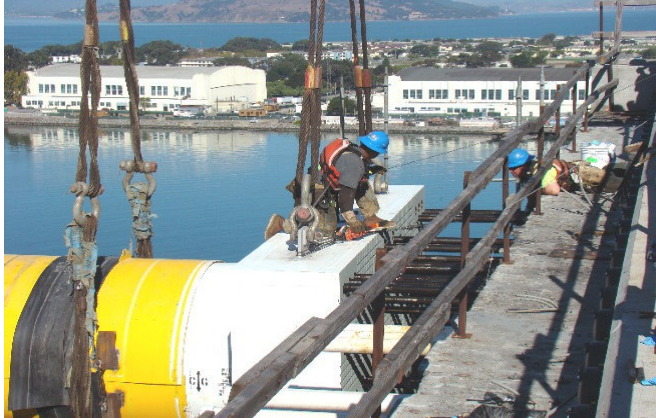
ABF ironworkers had to use comealongs to carefully guide the pipe beam assembly over the Macalloy rods without damaging the rod threads.

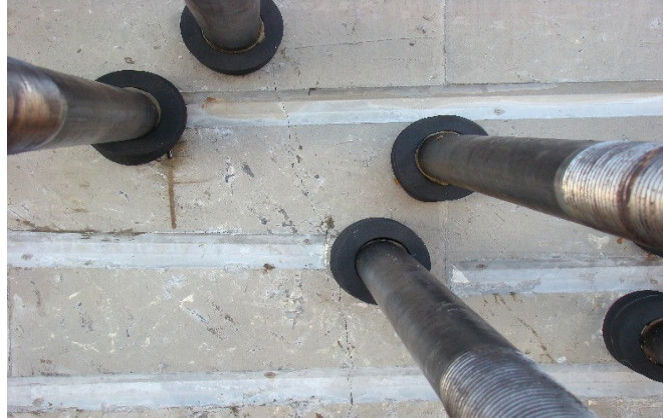
Four cracks were observed at the concrete face prior to the North W2W Hinge K pipe beam assembly erection.

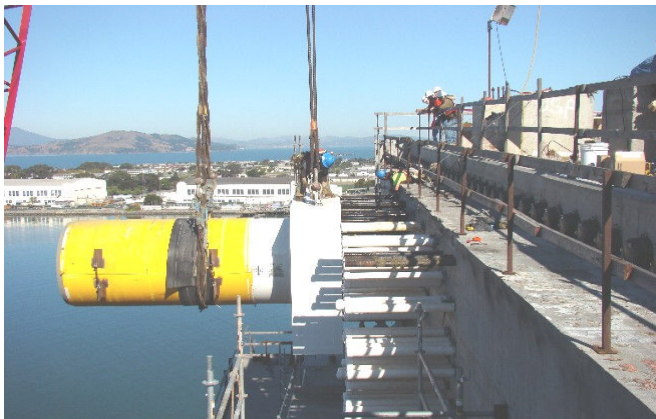
ABF in the process of positioning the North W2W Hinge K pipe beam assembly over the Macalloy rods embedded in the concrete at the W2 cap beam.

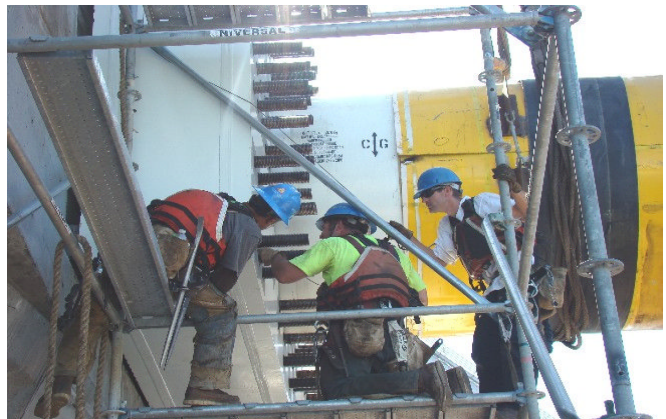
ABF ironworkers trying to remove a PVC guide pipe in the lower north corner. The whole assembly had to be pushed back in order to remove the PVC pipe.

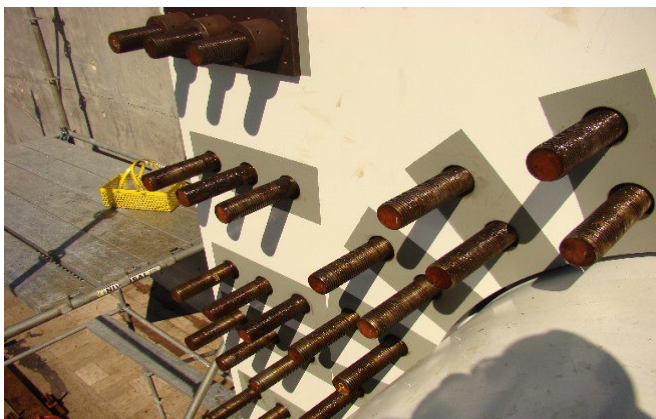
A check was made to see if any of the Macalloy rod threads were damaged during erection. No damage was seen.

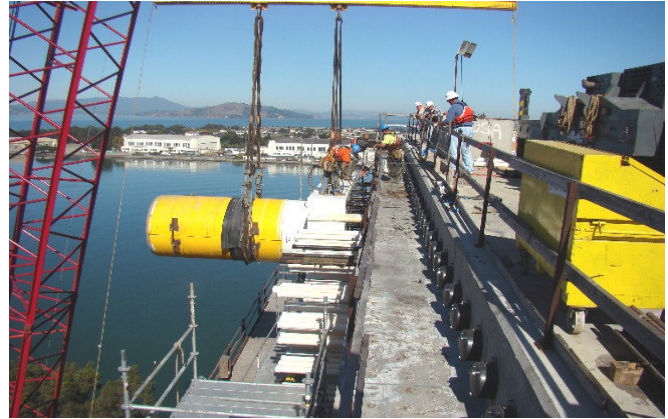
Continuing to pull the pipe beam assembly closer to W2. It appeared that the grease on the rods assisted the ironworkers pulling the pipe beam.

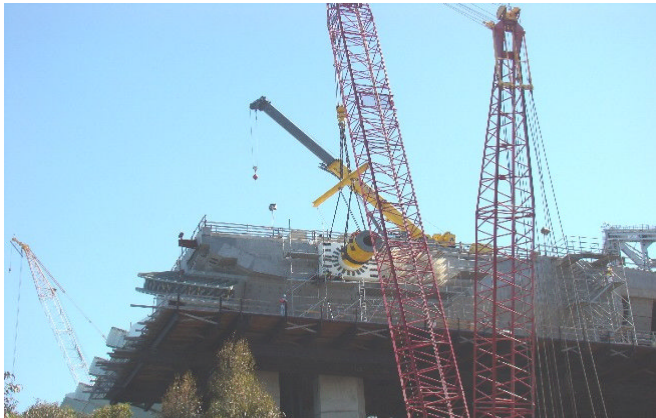
The first Hinge K pipe beam assembly erection was completed at noon.

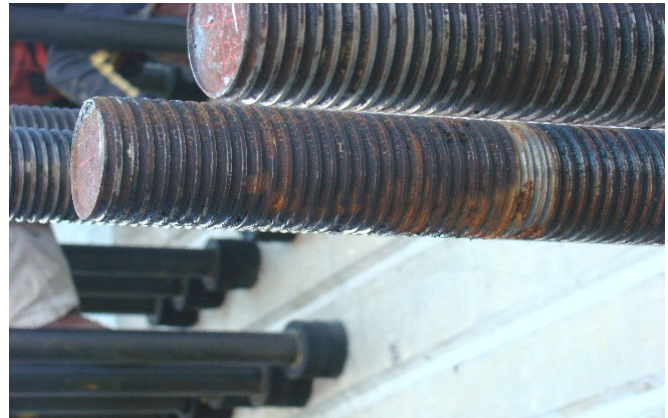
Rust seen on the threads of a Macalloy rod, overall the rods appeared to be in good shape with no or minimal rust.

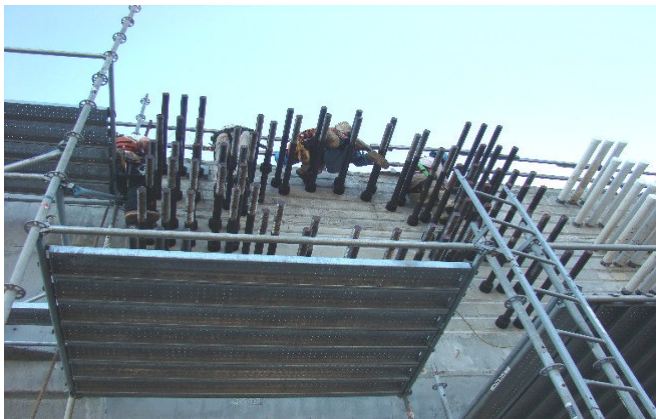
ABF ironworkers and laborers applying grease to the exposed portions of the Macalloy rods along the entire length of the rod.

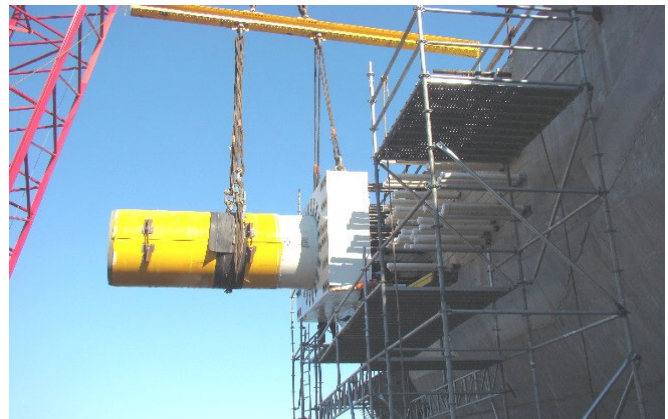
ABF in the process of positioning the North W2W Hinge K pipe beam assembly over the Macalloy rods embedded in the concrete at the W2 cap beam.

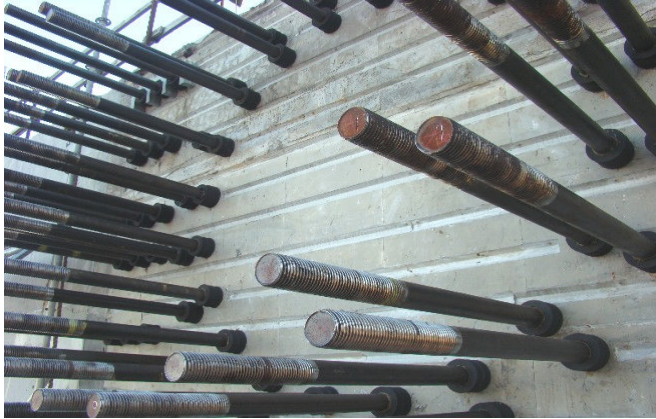
I explained to Scott and ABF engineer Zach Lauria the importance of achieving a proper bond between the concrete and grout. The quality of cleaning concrete surface for the North W2W Hinge K pipe beam assembly was marginal. However it was cleaned and the shear keys in the concrete and the grid pattern etched in the base plate of the Hinge K pipe beam assembly should provide enough shear resistance.

Concrete surface for the North W2W Hinge K that was cleaned by ABF laborers yesterday afternoon with a wire brush.

Apparently there was some confusion yesterday regarding this requirement. Prior to the placement of the North W2W Hinge K pipe beam assembly I approved the condition of the Macalloy rods. I did have ABF laborers clean a few additional areas on the concrete prior to erection. I discussed the expectations with ABF superintendent Scott Smith for the concrete surface and Macalloy rods so that there was no confusion. I recommended cleaning the concrete surface with a powerwasher or grinder sanding blade to increase the quality of the concrete surface since using a wire brush isn't the best method to clean the debris from the surface.

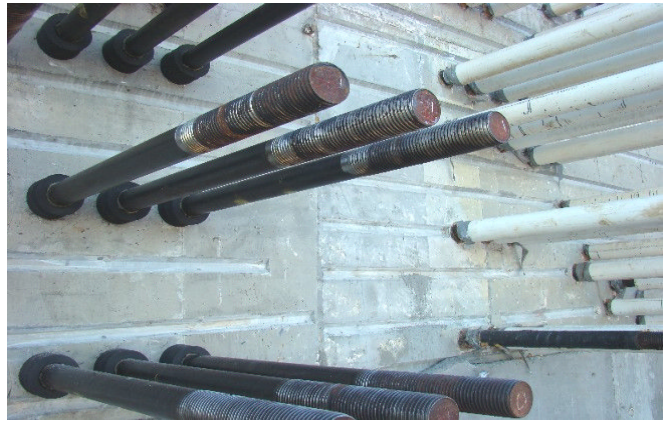
The Macalloy rods were mistakenly cleaned yesterday after the Denso tape and paste was removed. The rods needed to be greased for corrosion protection

- Due to the transgressions yesterday evening I was onsite at the beginning of the shift to assess the condition of the prep work. Brian Boal and Bob Brignano accepted the condition of the concrete surface late in the afternoon yesterday. I informed ABF superintendent Scott Smith that the surface was acceptable based on the Brian and Bob's evaluation. However I informed him that grease needed to be applied to the Macalloy rods for corrosion protection.

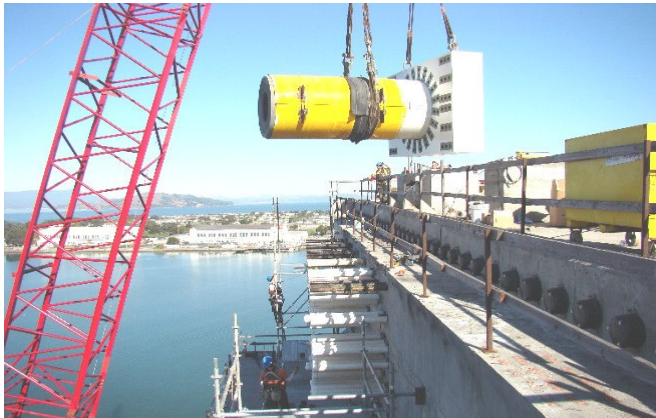
ABF beginning to position the North W2W Hinge K pipe beam assembly over the Macalloy rods embedded in the concrete at the W2 cap beam.

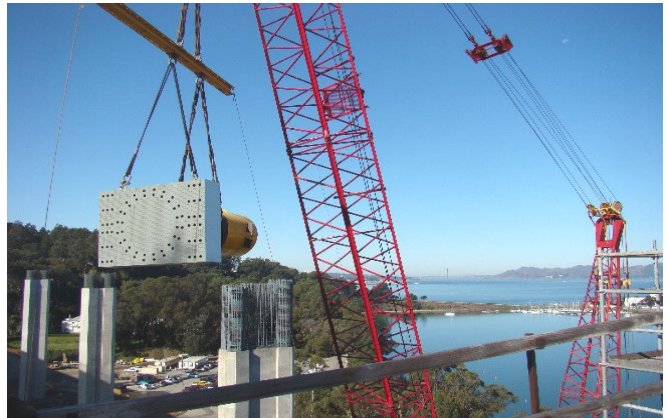
Erection of the North W2W Hinge K pipe beam assembly began at 9:30am after the concrete surface and Macalloy prep work was completed.
